Condition Report

Gate Lodge

Central Mental Hospital, Dundrum Road, Dundrum,
Dublin 14

Date: March 2022

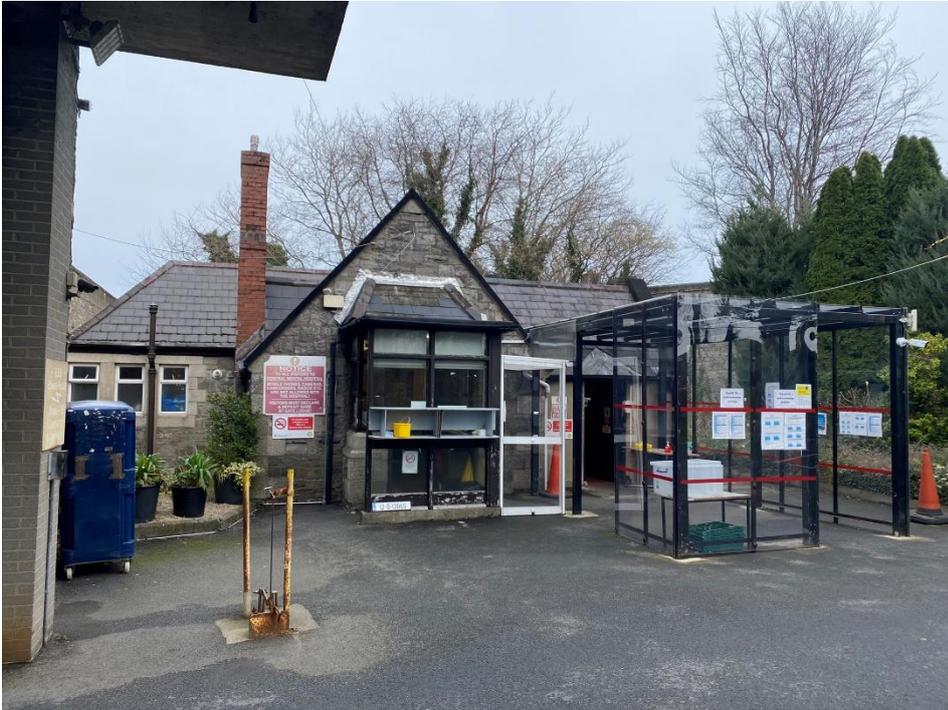
Fig. 04: Southern elevation with temporary structure for Covid-19 screening on right hand side.

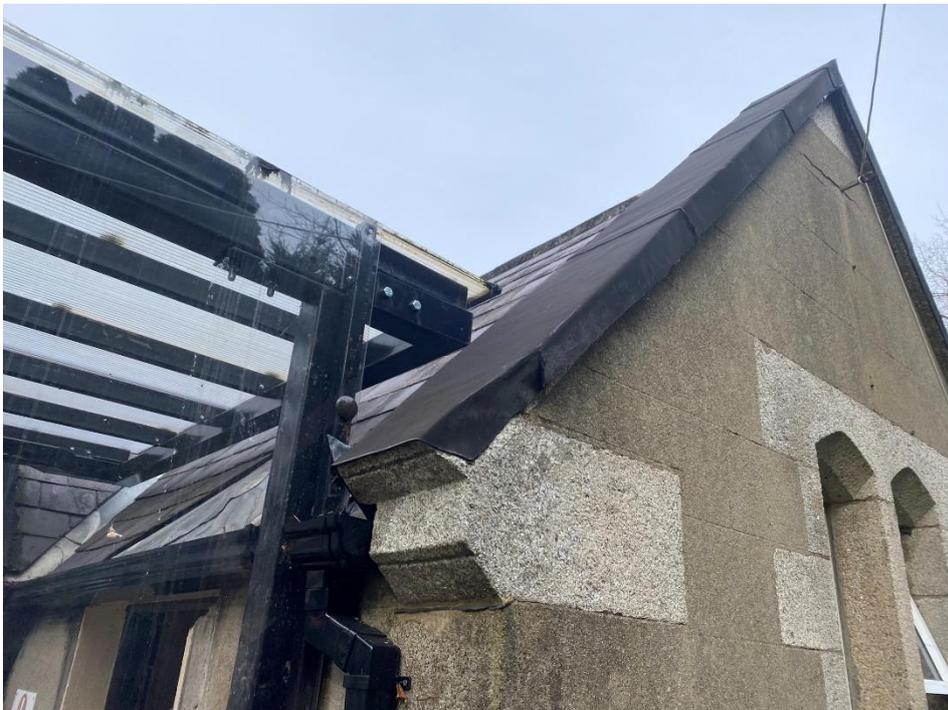
Fig. 05: Junction of temporary screening area and roof of Gate Lodge.

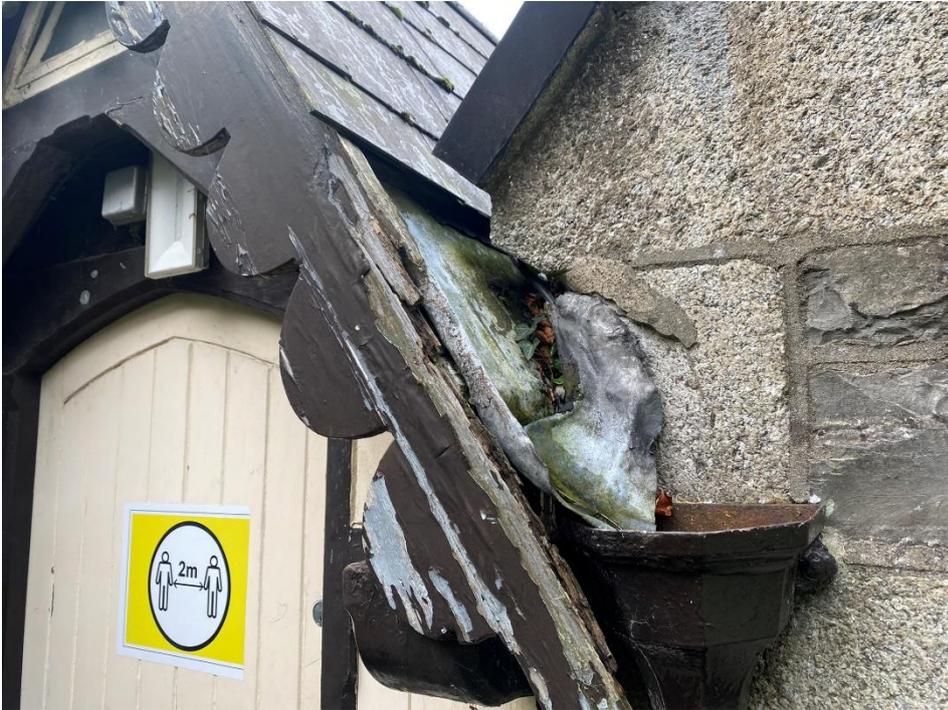
Fig. 06: Water ingress resulting in deterioration of decorative fascia to door at eastern elevation.

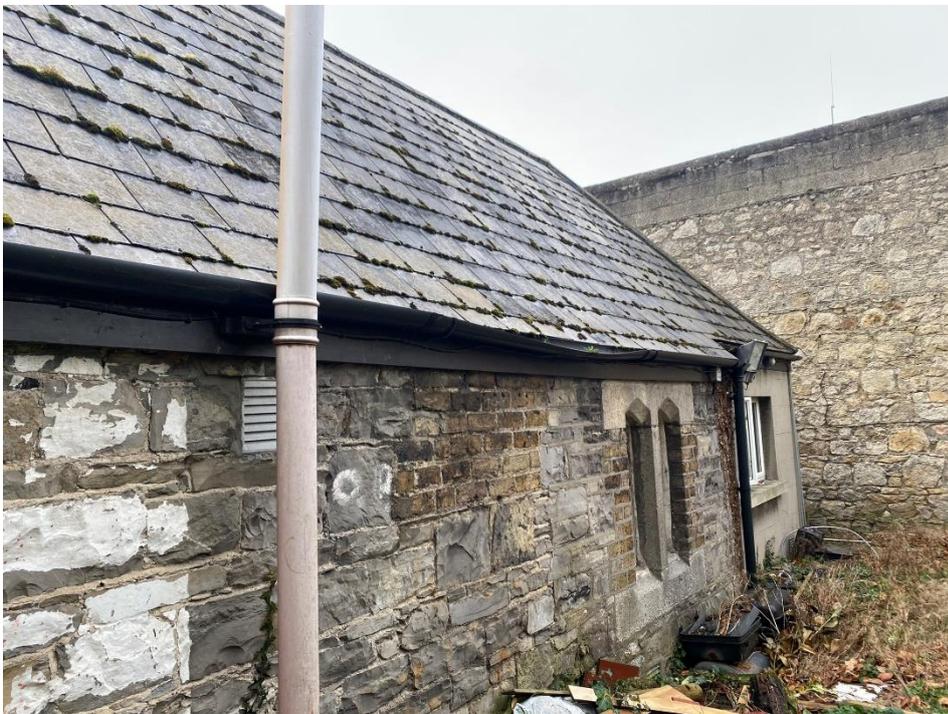
Fig. 07: Moss visible on roof slates at northern elevation. Note debris at base of building blocking sub-floor ventilation grilles

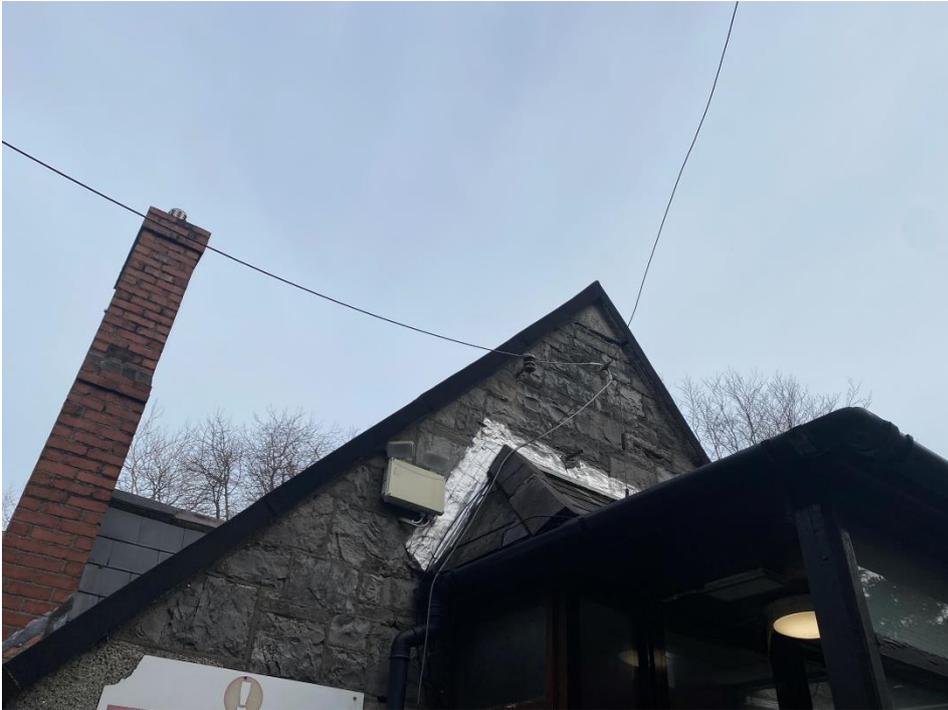
Poor quality flashing used above porch on south façade. Bitumen covering to stone barges, suggesting issues with moisture penetration in the past. This is unsightly and a more satisfactory repair will be preferable. Debris noted in gutters / downpipes throughout increasing the risk of water ingress. Evidence of former repairs to roof noted at brick chimney with unsightly finish and flashing remaining. Section of roof to south façade appears to have been recently removed with a significant amount of lead flashing exposed to the elements.

Fig. 08: Flashing where lean-to roof at southern elevation meets stone wall.

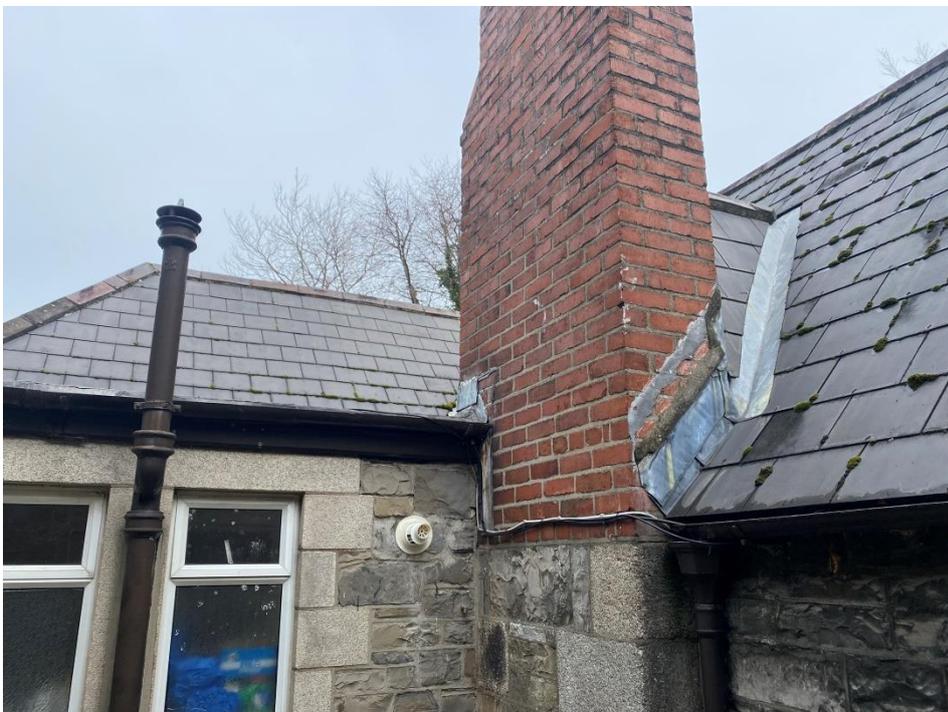
Fig. 09: Note previous line of flashing on brick chimney breast; gas balanced flue visible.

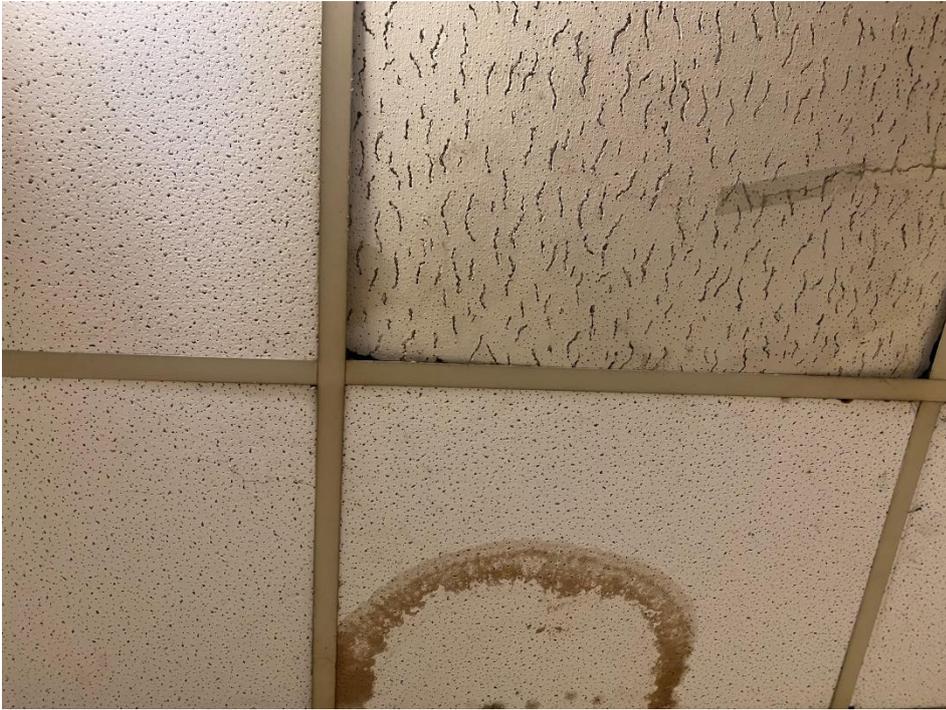
Ceilings throughout are generally formed in plasterboard with a gypsum skim finish with no decorative details noted. A suspended ceiling has been provided in the reception, which is in poor condition, showing evidence of water ingress, and will require to be replaced and the source of the moisture should be investigated.

Fig. 10: Deterioration/rot of suspended ceiling panels inside Gate Lodge due to water ingress.
